Pinole Creek Watershed Sediment Source Assessment

SFEI Contribution 316
January 2005

Prepared by the San Francisco Estuary Institute

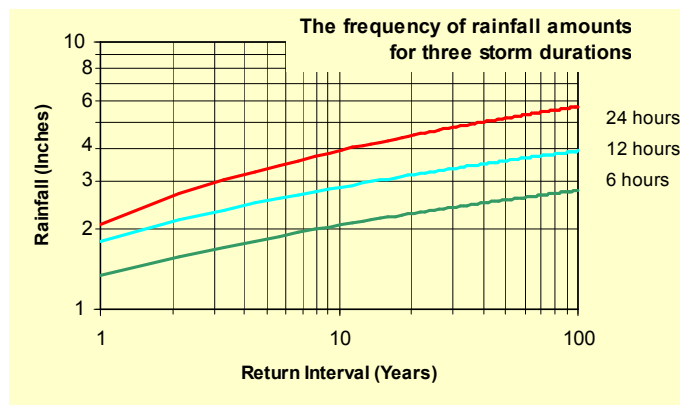
Figure 5. Rainfall frequency for three storm durations.

On average 90% of the annual rainfall occurs during the winter season (November 1st – April 30th) on just 54 days (City of Richmond data). Rainfall on these days can be very intense and cause flooding and erosion throughout the watershed. For example, on January 4th 1982, 6.83 inches of rain fell in a 24-hour period. This storm had an estimated return period greater than 200 years. Once every 10 years on average the watershed is likely to receive 2.1 inches in a 6-hour period, 3 inches in a 12-hour period or 4 inches in a 24-hour period (Figure 5).

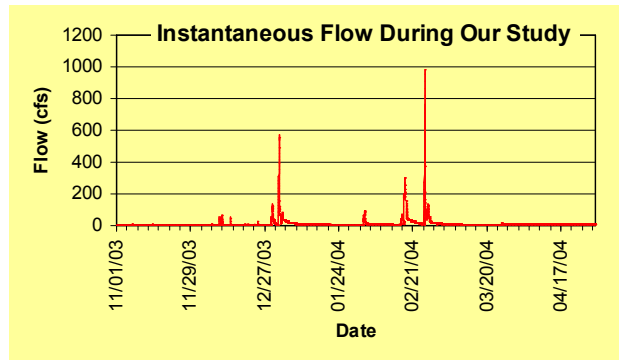
Figure 10. Instantaneous flow measured on Pinole Creek at Pinole Valley Road Bridge number 5.

Pinole Valley Road Bridge number 5 reached 6.2 feet in depth and flow peaked at 981 cfs (Figure 10). Using the historic flow record as a guide, a flow of this size is likely to occur on average once every 5 years. Although there were 10 storms during the year when rainfall exceeded 1 inch, only 3 of these storms produced a large amount of flow. This was because rainfall for the season needed to accumulate to about 6.5 inches before storms produced even 1 foot of increased flow depth or 60 cfs at peak flow. The historic data suggests that on average it takes about 7 inches of accumulated rainfall before significant flow occurs. The 3 largest storms occurred on January 1st 2004 at 12 inches of accumulated rainfall, February 16th 2004 at 17 inches of accumulated rainfall and February 25th 2004 after 19 inches of accumulated rainfall. These storms accounted for about 30% of the wet season flow. Although dry season flow was not a focus of our work, during the study we observed a flow of 0.1 cfs sustained throughout the summer.

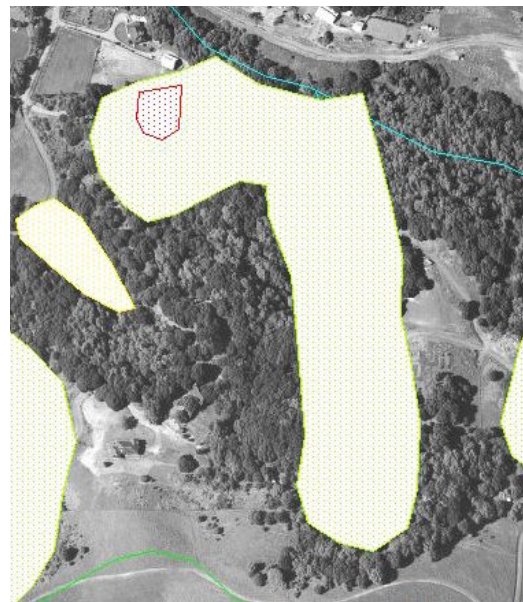
Figure 14. Example of a typical Holocene landslide with a younger active landslide mapped within it.

A Holocene landslide is one that shows evidence of movement that occurred more than 100 years ago. However, the characteristics of these slides suggest that they occurred much longer ago, when climatic conditions were much wetter (in the Holocene Period, from 10,000 years before present to present). These landslide types, also referred to as ancient or fossil landslides in the literature, remain visible on the landscape for hundreds to thousands of years after they moved and then stabilized (Cruden and Varnes, 1996). Typically, this slide type covers a large portion of the hillslope, is much thicker than other slide types, and is only evident from its subtle topography and shape. In the Pinole Creek watershed, Holocene landslides are the largest of the four slide classes, typically ranging from 1,000 to 100,000 m³ (35,315 to 3,531,500 ft³). These slides cover a much larger area, and are more complex in shape than active or dormant slides probably because they express multiple triggering events that occurred over many years. Often, within a mapped Holocene landslide area, a smaller portion has been reactivated and is thus mapped as either an active or dormant slide. The large area of these Holocene slides will not likely reactivate under today's climatic regime.

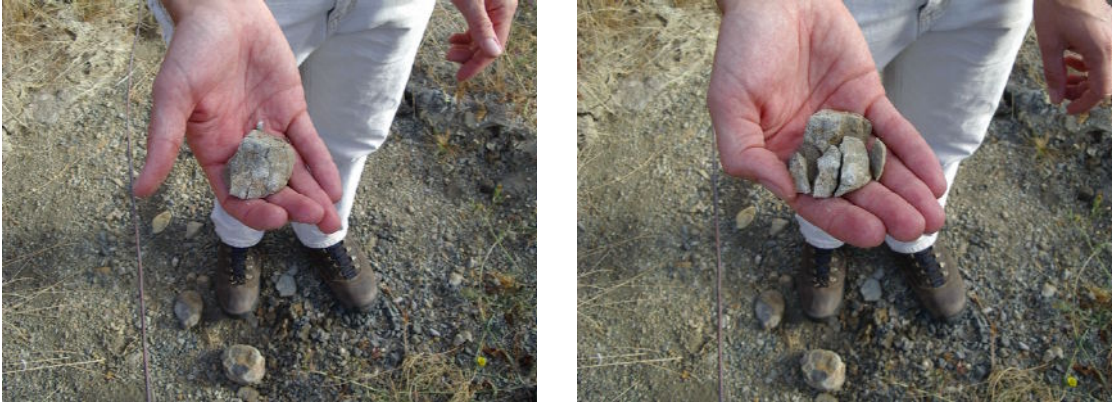
Figure 18. Weathering properties of Tshc and Ts? clasts found in a gully in the Pavon Creeks sub-basin.

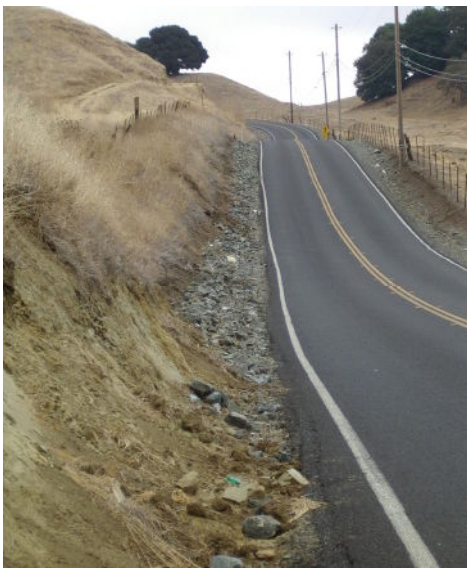
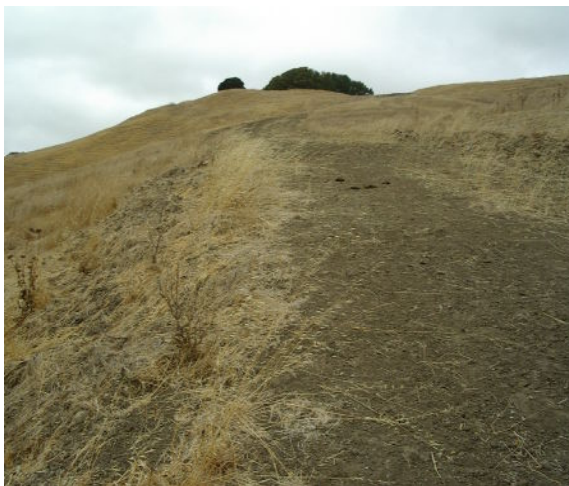
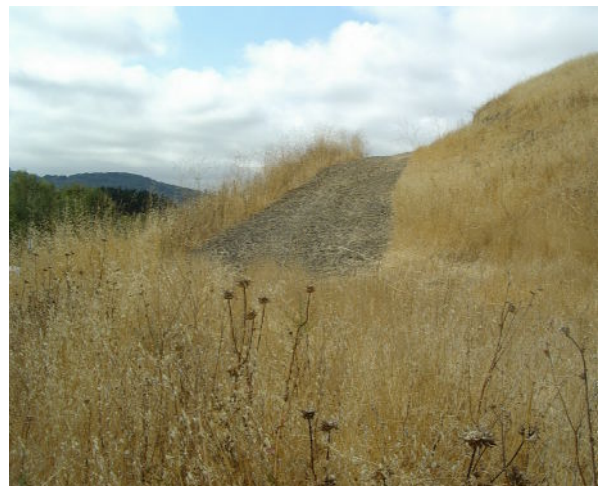
Figure 21. Photos illustrating the four types of road classification. A) Paved road, B) highly traveled gravel or dirt ranch road, C) rarely traveled fire trail, and D) non-traveled fire break.

Lisa Hokholt of the USDA Natural Resources Conservation Service and Sarah Pearce (SFEI) completed a reconnaissance of different road types throughout the watershed, assessing the roads for their current condition, and any observable erosion. Roads were classified into four types: (A) paved roads, (B) highly traveled residential or ranch gravel and dirt roads (ranch roads), (C) rarely traveled dirt fire roads (fire trails), and (D) non-traveled fire breaks. An example location of each type of road classification is shown in Figure 21.

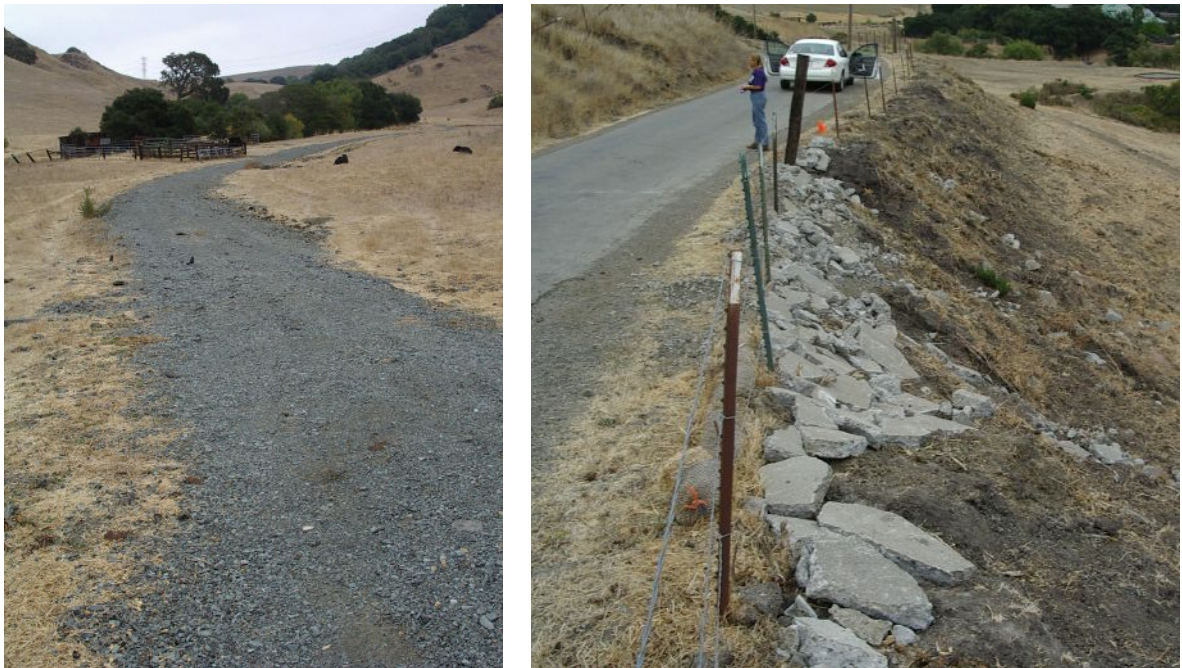
Figure 22. Photos illustrating a well-maintained gravel ranch road, and a poorly maintained paved road.

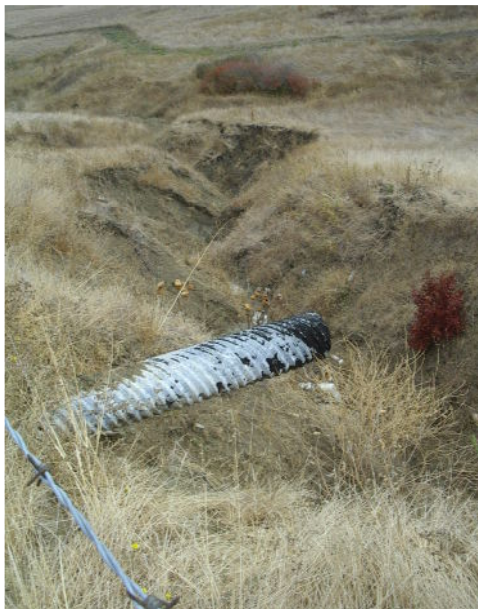
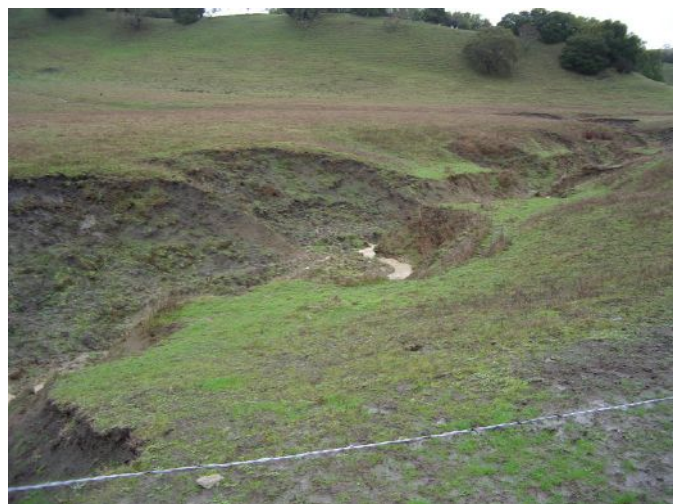
Figure 23. Photographs of a hanging culvert draining Castro Ranch Road, and of the gully that has developed downstream.

Overall, roads in the Pinole Creek watershed are relatively well maintained, and are not a significant source of sediment supply to the creeks. Of the four categories, paved roads are the largest overall source of sediment because of their greater total length, and a higher percentage of areas that are experiencing severe or very severe erosion. Drainage and concentrated runoff from the impervious paved roads typically causes the erosion, either forming gullies or causing bed incision. For example, the concentrated drainage from Castro Ranch Road has formed gullies in the Pavon Creeks tributary to Pinole Creek. When Castro Ranch Road was relocated in 1985, the drainage from the road surface was funneled via culverts into small existing tributary drainages adjacent to the road. A problem did not exist until the wet season of 1993, when heavy rains caused the formation of the large gully that is still currently observed (R. Hartwell, pers. comm.) (Figures 23 and 24). The eroded material was transported downstream, where a portion deposited on the south side of Pinole Valley Road, and the remainder was input into Pinole Creek. We acknowledge that this particular location is logistically very difficult to maintain a safe and functioning road. The Pavon Creeks sub-basin is underlain by a rock type that is very prone to failure, and an active fault trace has been identified along the southern boundary of the sub-basin (B. Nuzum, pers. comm.). Prior to road relocation, the road was continually damaged by the movement of landslides. The existing road location has also been damaged by a small landslide in 1995 and 1997 (B. Fernandez, pers. comm.). While the existing location is more stable, routing road drainage without causing significant erosion has now become an issue. Additionally, the Simas Creek tributary with the Pinole Creek mainstem is located immediately upstream of the intersection of Pinole Valley Road/Alhambra Valley Road and Castro Ranch Road (locally known as the “Y”), and has caused other erosion related road repairs in this location during the past 10 years.

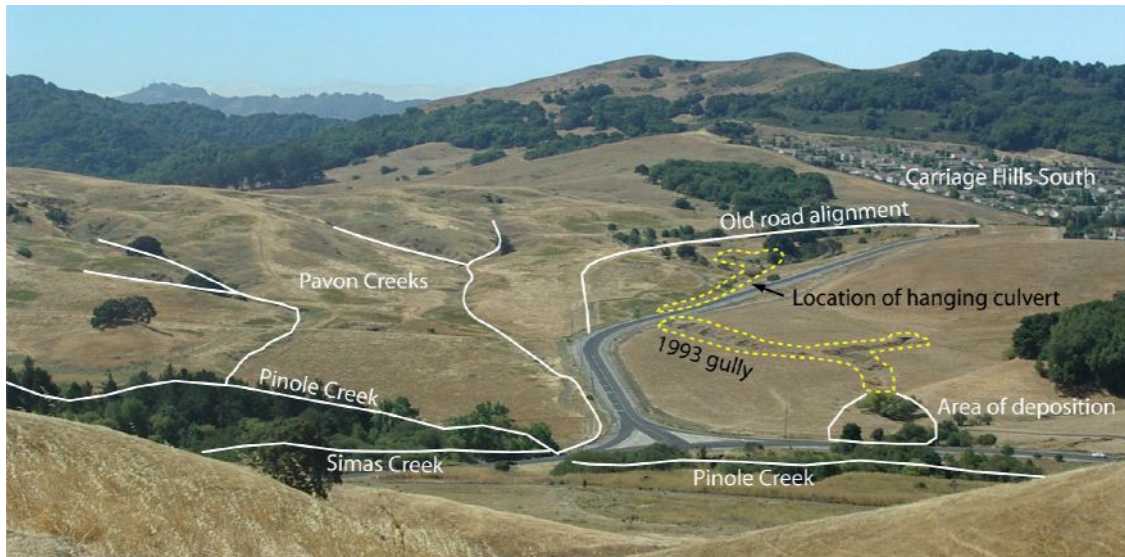
Figure 24. Photograph looking across the valley at Castro Ranch Road and the Pavon Creeks area. Photograph shows the current alignment of the road, past alignment, location of hanging culvert (also shown in Figure 23), gully location (dashed yellow line), and area of sediment deposition.

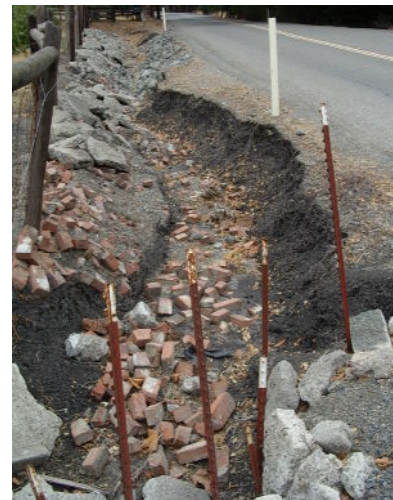
Figure 25. An example of a poorly constructed and maintained inboard ditch that is contributing sediment.

Based upon observations made during our reconnaissance, it appears that only minor areas of the road surfaces are actually eroding. Instead, we observed localized areas of poorly designed and maintained inboard ditches and culverts draining road surface runoff which appear to be responsible for a majority of the road-related erosion (Figure 25). Because these areas are few in number, and relatively small in length, management efforts at these locations would likely be successful in reducing the amount of sediment supply from these locations. The gravel and dirt roads, fire trails, and firebreaks that are in good condition are not a significant source of sediment because they are well managed and maintained. In many locations, we observed features that reduced the erosion potential, such as remnant low vegetation on the road surface, outsloped roads (roads that disperse rather than concentrate runoff), and avoidance of creating roadside berms during annual road grading operations.

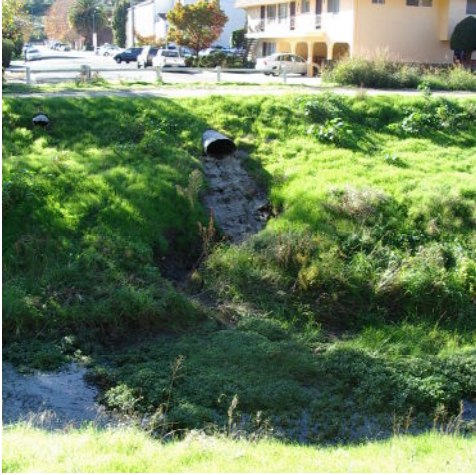
Figure 26. Example of minor channel bank erosion where a culvert draining city streets enters the mainstem channel.

steepened road cuts that could cause surface erosion or exacerbate landslide activity. In addition, the increased discharge of stormwater from these impervious areas can potentially erode sediment from the channel bed and banks; this is especially obvious

where culverts enter the channel. From values obtained in the literature, urban areas are known to supply 140 - 320 kg ha⁻¹yr⁻¹ of sediment to receiving waters (Australian Water Resources Council, 1981; Cordery, 1977; Letcher et al., 1999). Given the urban area of the watershed is approximately 709 ha (Contra Costa County Watershed Atlas, 2003), the urban areas likely contribute 99 – 227 metric tonnes of suspended sediment to the creek annually, much of which is manageable via best management practices such as vegetated swales and stormwater detention basins.

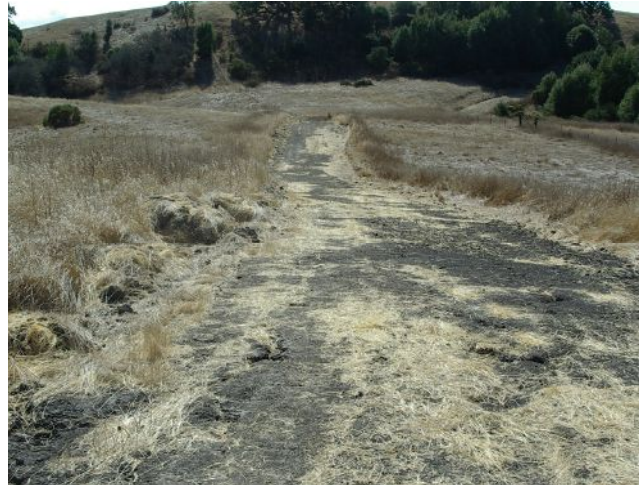
Figure 27. Example of a well-maintained fire trail that is not contributing a significant amount of sediment.

Type 2- The areas of open space that are managed and maintained for wildfire control, recreation, watershed land, and wildlife areas appear to only be contributing minor amounts of sediment. In these areas, the potential for sediment sourcing is from fire trails and firebreaks, as well as from any modification of drainage that could cause gully erosion, sheetwash erosion, or trigger or reactivate a landslide. However, our observations of these areas suggest that the current style of maintenance is doing an adequate job of limiting erosion of the road and fire break surfaces as well as limiting hydrologic modifications.

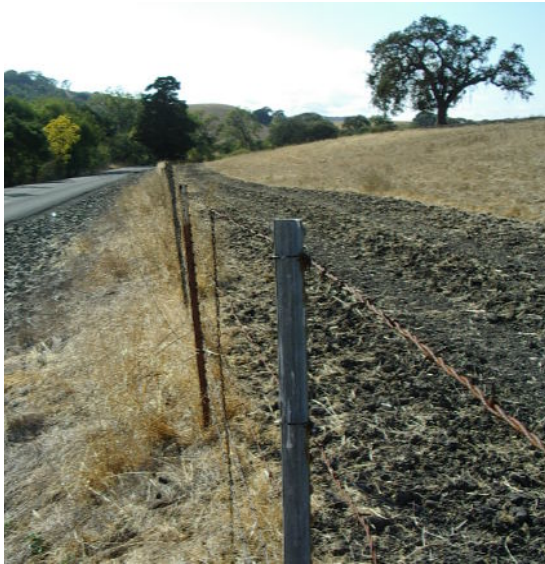
Figure 28. Example of a firebreak on EBMUD lands.

runoff. Wide firebreaks are mainly limited to areas adjacent to Pinole Valley Road, and most retain some vegetative material on the soil surface, which reduces raindrop splash erosion and slows runoff water velocity. The areas that are grazed currently have a low stocking rate, and the cattle are often rotated between pastures to reduce the effects of

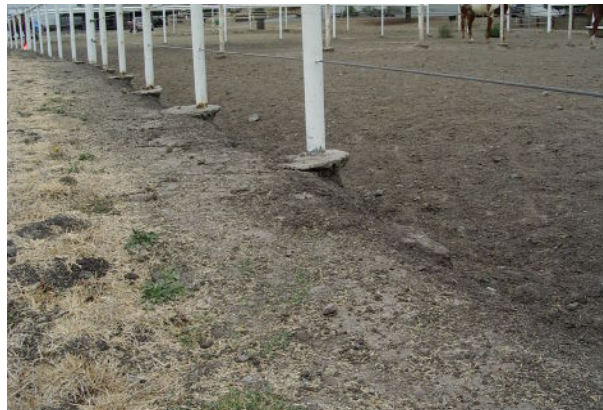
Figure 29. Exposed fence post bases due to surface erosion in a horse pasture.

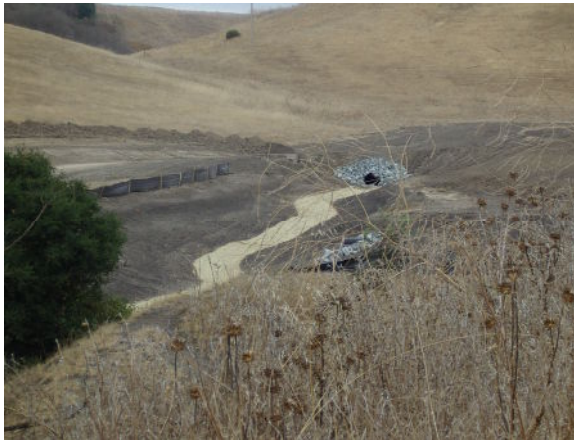
Figure 30. Erosion control efforts associated with the installation of a new equestrian facility (work in progress).

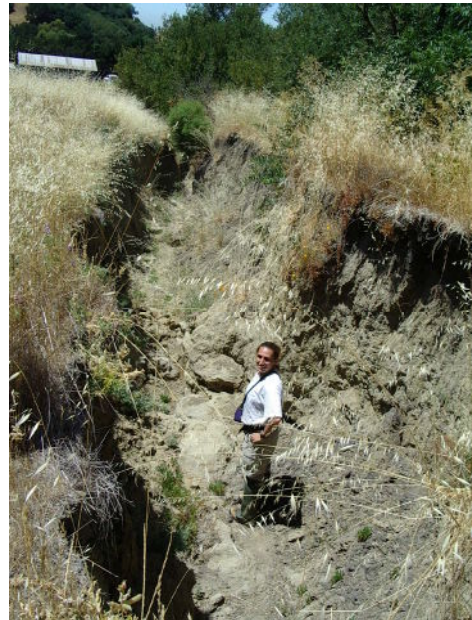
Figure 31. Gully caused by the resultant increase in runoff due to historic removal of topsoil in a sub-basin.

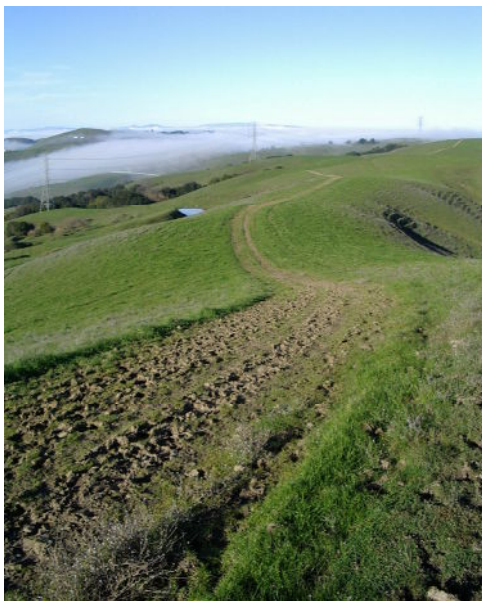
Figure 32. Example of a well-maintained fire trail on the East Bay Regional Park District lands.

large, naturally occurring landslides. The fire trails appear to be well maintained, and are not contributing measurable amounts of sediment to the fluvial system. However, because of the high landslide-associated erosion potential, it is critical that land managers in this area are aware of the potential negative consequences of land use modifications (such as road building, vegetation removal, excavation, etc.). Current and future management should strive to limit activity that modifies drainage patterns or increases runoff in these sub-basins.

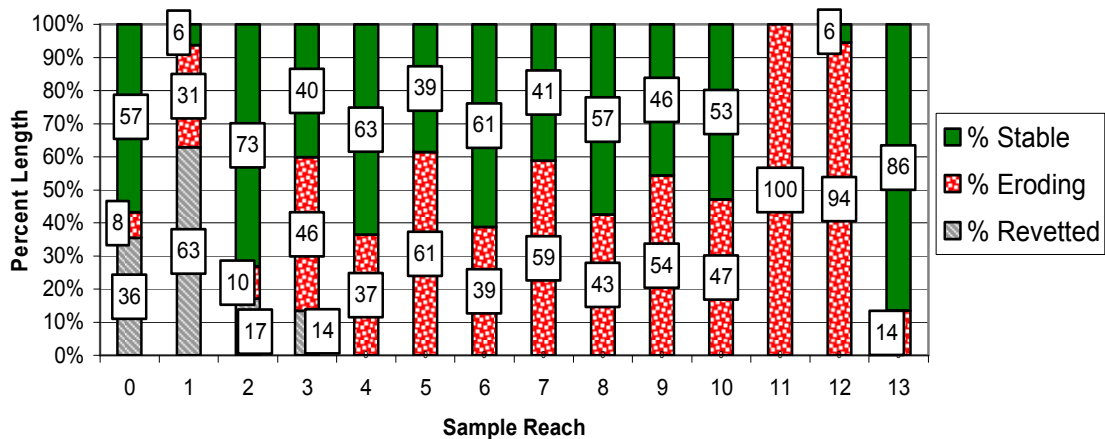
Figure 34. Graph illustrating the percentages of channel bank in each sample reach that are stable, eroding, or revetted.

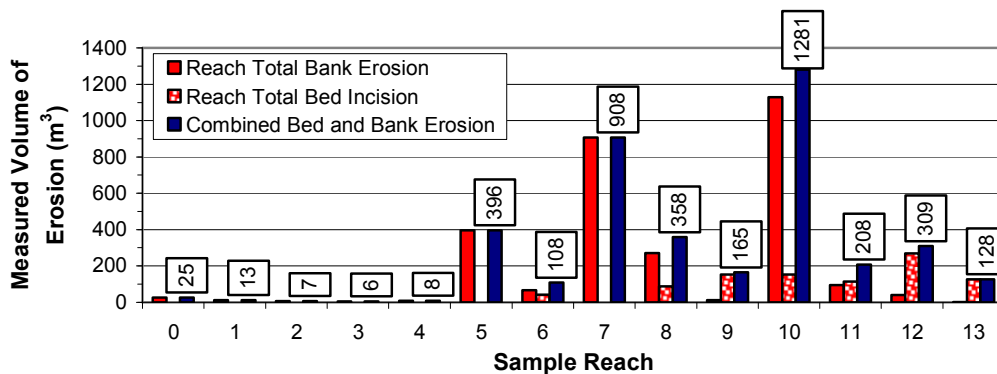
Figure 35. Reach total measured bank erosion, bed incision, and combined erosion and incision in each sample reach.

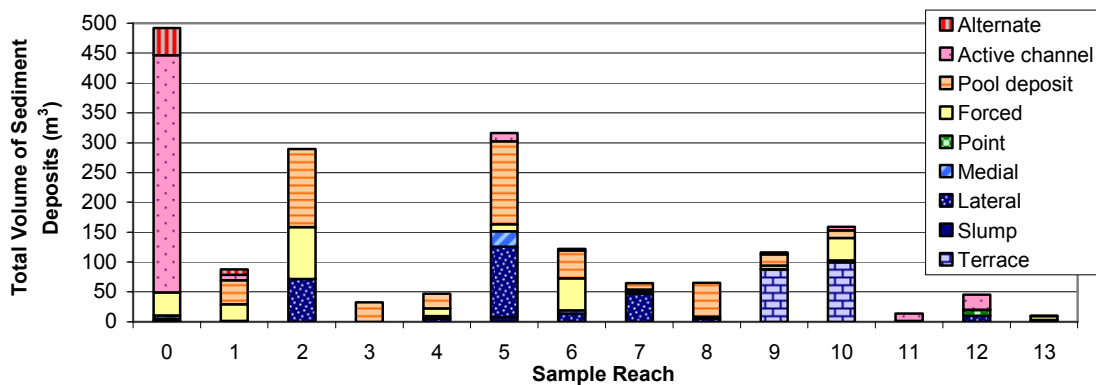
Figure 36. Total volume and type of sediment deposits (in m³) in each sample reach.

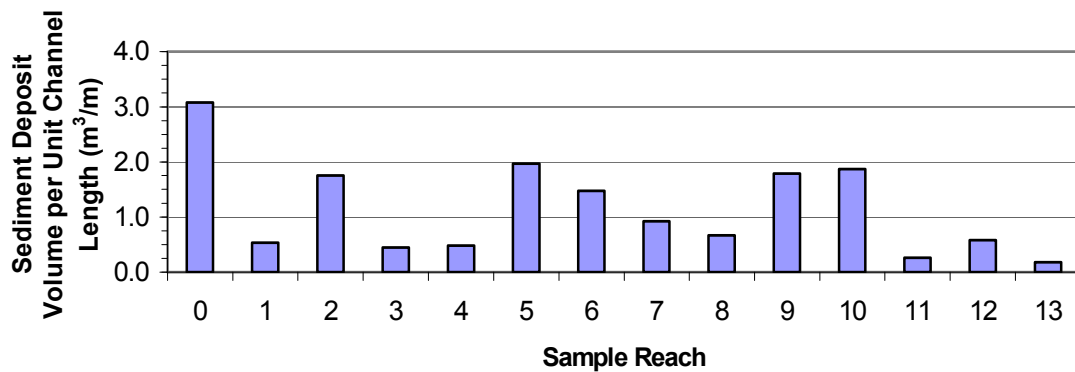
Figure 37. Total volume of sediment storage per unit channel length in each sample reach.

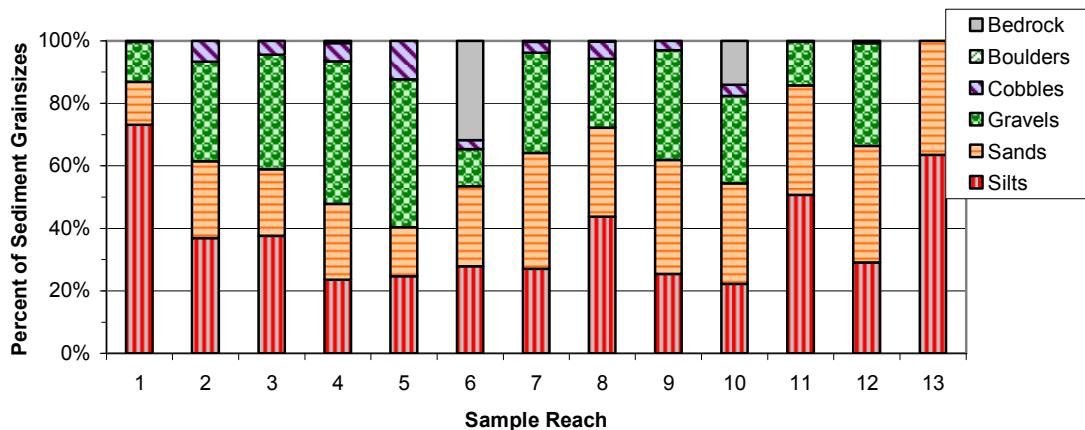
Figure 39. Simplified grain size distribution for each sample reach. Silts are < 0.5 mm, sands are 0.5 mm to 2 mm, gravels are 2 mm to 16 mm, cobbles are 16 mm to 256 mm, and bedrock is > 256 mm.

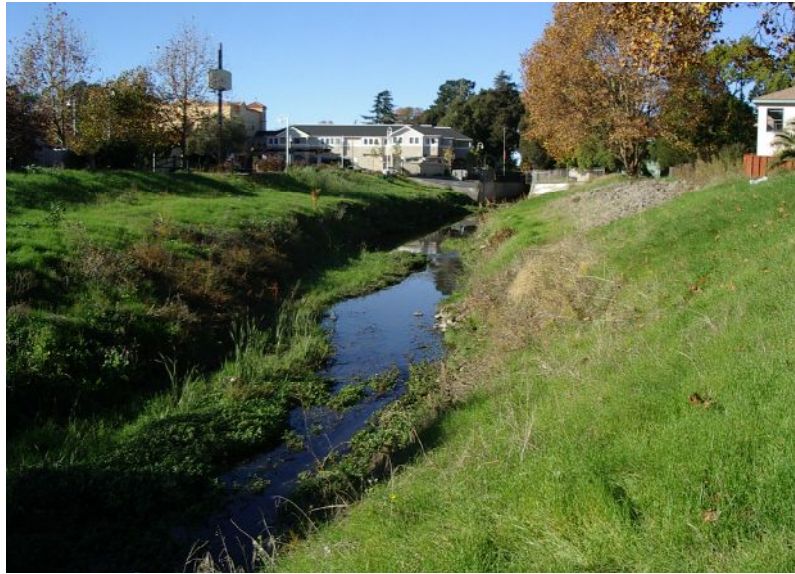
Figure 43. Photograph illustrating typical cross-sectional geometry in the fluvial portion of the flood control channel reach.

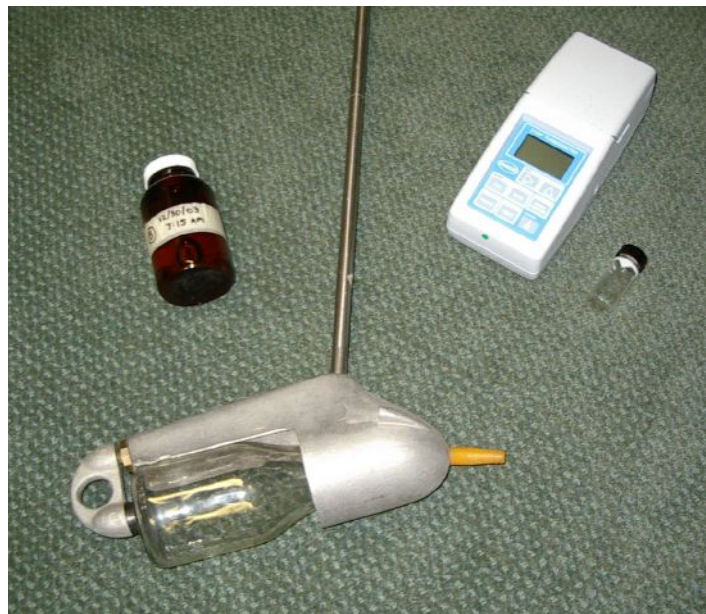
Figure 44. Photograph of the DH-48 hand-held depth integrating sampler, amber glass suspended sediment sampling bottle, the portable turbidimeter, and clear glass turbidity sample container.

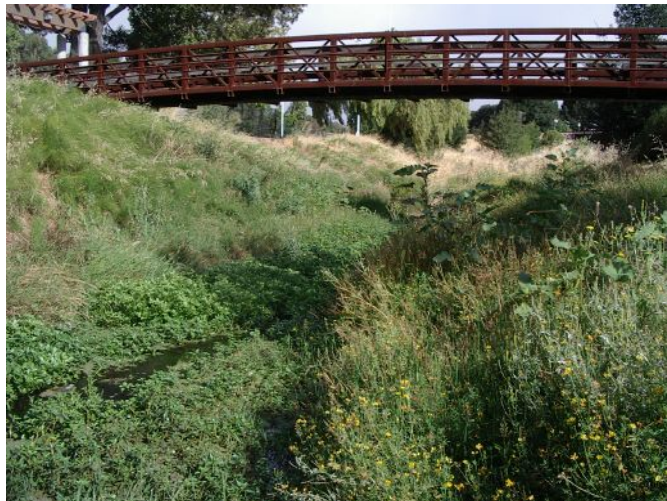
Figure 54. Pinole Creek at the Senior Center, July 22, 2004.

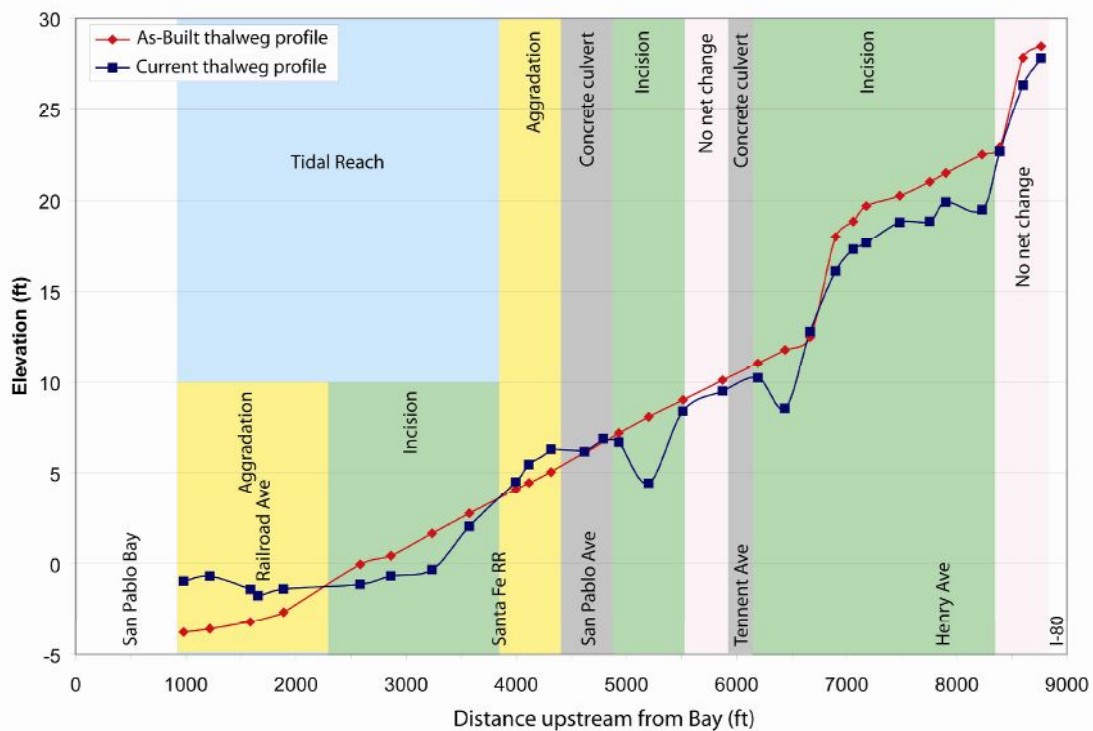
Figure 58. Thalweg longitudinal profile of the flood control channel. Red line is the “as-built” channel profile in 1965, blue line is the channel profile in 2003.
